Subj: VP-7 AAR ser 1-64A concerning SP-2E BuNo 131481 accident  
occurring 11 May 1964, pilot KOPP

## AIRCRAFT ACCIDENT REPORT

18. BRIEF DESCRIPTION OF MISHAP <b>COLLISION WITH WATER, CAUSE UNKNOWN</b>		19. ELEVATION AT TIME OF MISHAP <b>S L 0 TETRAIN 0</b>		
20. LIST MODEL & NO. REPORTING CUSTODIAN AND DAMAGE CLASSIFICATION OF ANY OTHER A/C INVOLVED (Complete OPNAV Form 3750-1 for each A/C)

PART VI - DAMAGE TO THE AIRCRAFT

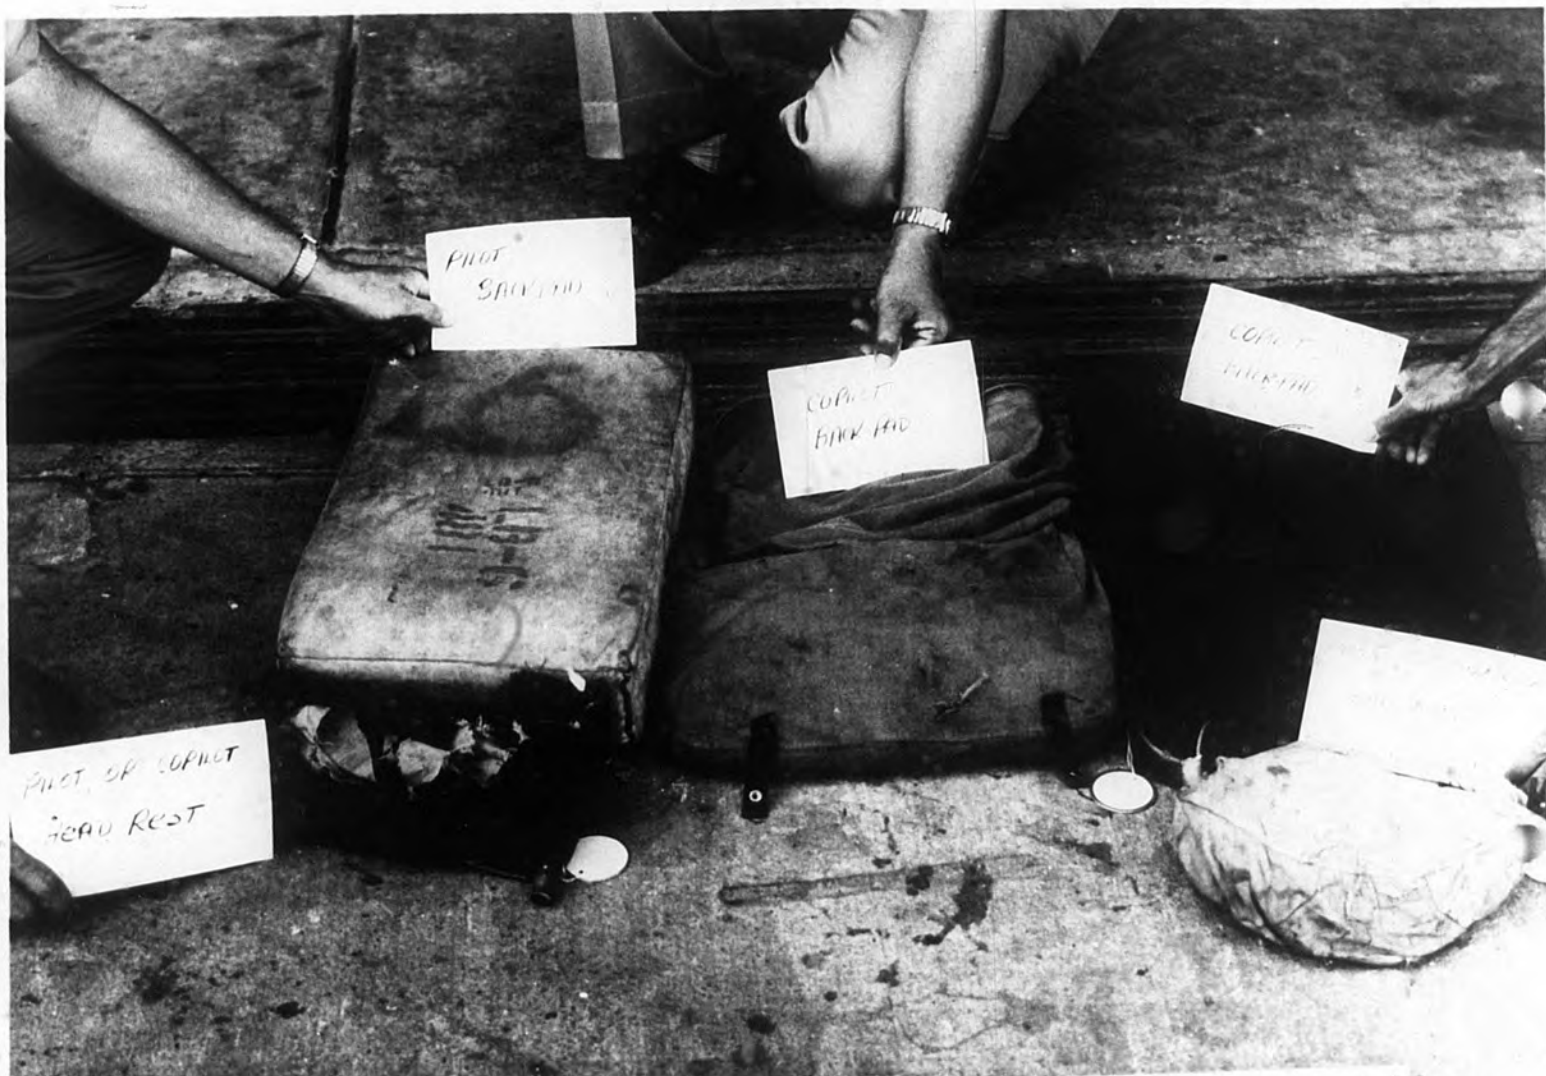
EXHIBIT (H)

1. As a result of the crash the aircraft was demolished. As shown in enclosures (3) and (4) only small pieces of the aircraft were recovered. These pieces were from many locations within the aircraft. The condition of these pieces indicate that the aircraft hit the water with a violent force and that there was substantial breaking up of the aircraft as a result of the impact.
